**MARINE INVESTIGATION REPORT
M10F0003**

KNOCKDOWN AND CAPSIZING

**SAIL TRAINING YACHT *CONCORDIA*
300 MILES SSE OFF RIO DE JANEIRO, BRAZIL
17 FEBRUARY 2010**

Report Number M10F0003

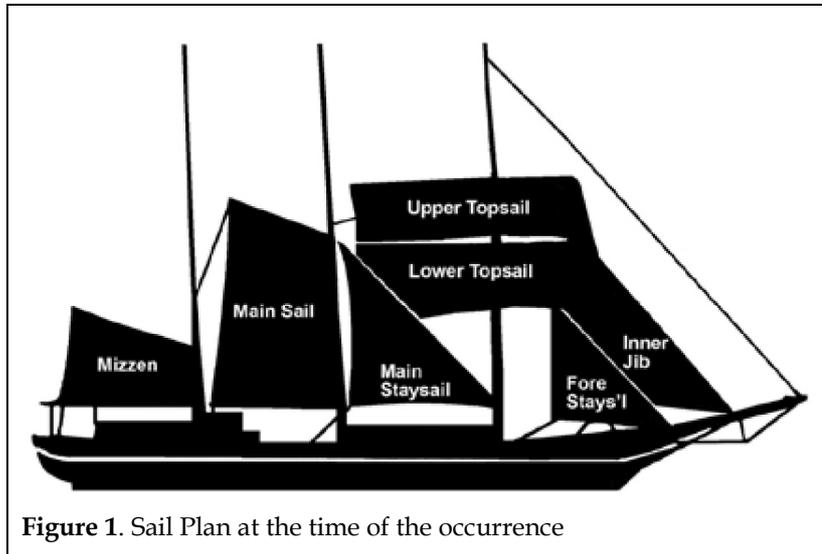
Figure 1. Sail Plan at the time of the occurrence

2/O discussed the sail plan and the 2/O was advised that it was suitable for winds up to 40 knots. The master instructed the 2/O to maintain, if possible, the wind abaft the beam and to keep a comfortable heel angle for the classes. He also instructed the 2/O to brace the yards and to trim the sails as required as the wind backed, and to bear off to port and run before any squalls. The 2/O and master then discussed action to be taken in case it was necessary to reduce sail. The vessel was on a broad reach,¹³ on a starboard tack, with a course between 200° and 220° (G). The apparent wind speeds were between 15 to 18 knots, with seas of 1.5 to 2 meters from the north and a long, low southerly swell. The air temperature was between 29°C and 31°C.

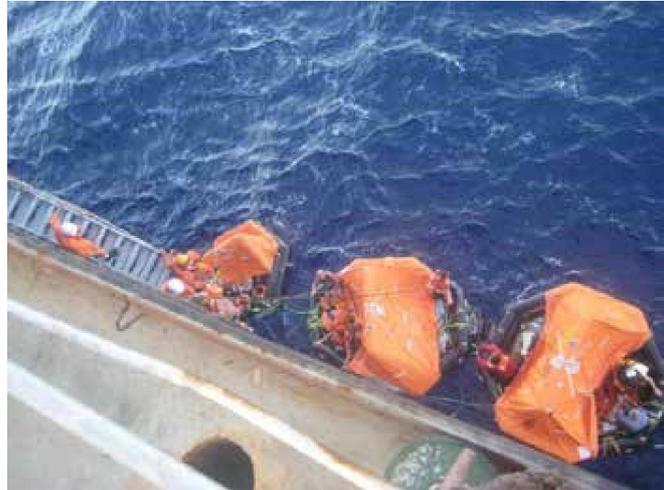
Photo 2. Liferafts alongside *Hokuetsu Delight*

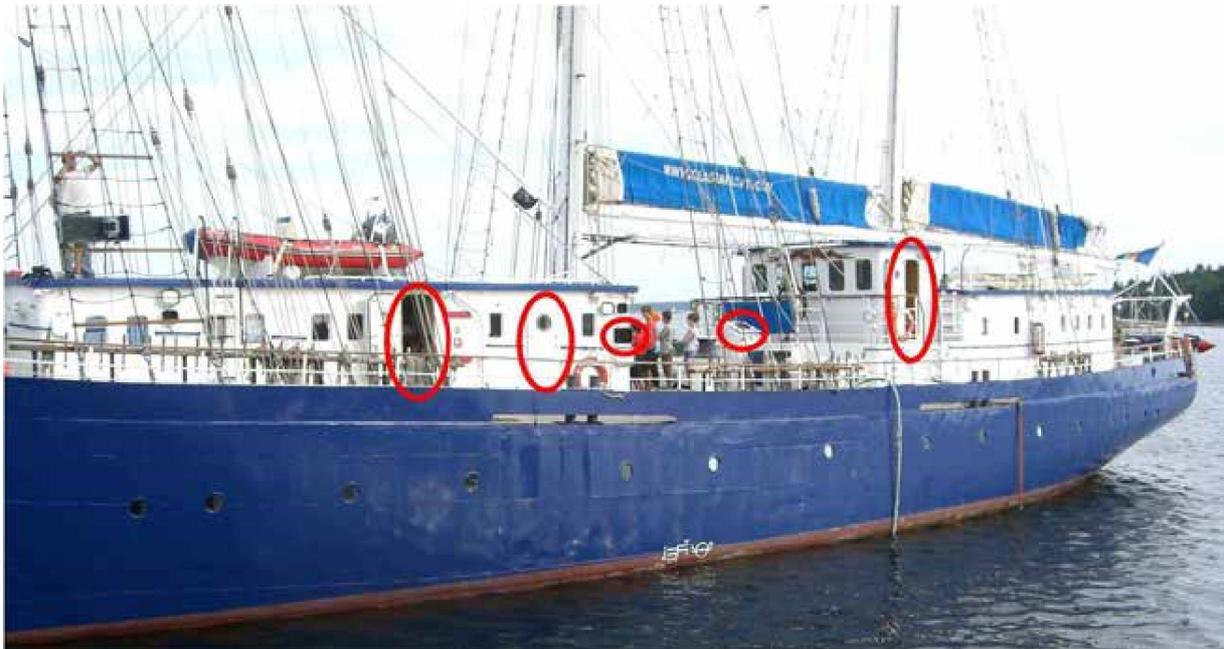
Description	Angle of Immersion
Galley Door (forward deckhouse, port side)	56.5°
Mess Door (forward deckhouse, port side)	58.4°
Sanitary Exhaust Vent (forward deckhouse, port side) ^{Note}	65.0°
Radio Room Window (aft deckhouse, port side)	68.6°
Wheelhouse Door (aft deckhouse, port side)	74.2°
Chart room interior door	87.9°
Engine Exhaust (top of mizzen mast) ^{Note}	91.7°
Engine Room Skylight (forward of wheelhouse, offset to starboard) ^{Note}	100.5°
Mess Stairway (inside forward deckhouse) ^{Note}	116.5°

Note: Immersion of these openings would lead to downflooding of the hull.

**Photo 3.** Some critical port side openings

Circled from forward to aft: mess room door, galley door, sanitary exhaust vent, engine room skylight and wheelhouse door.

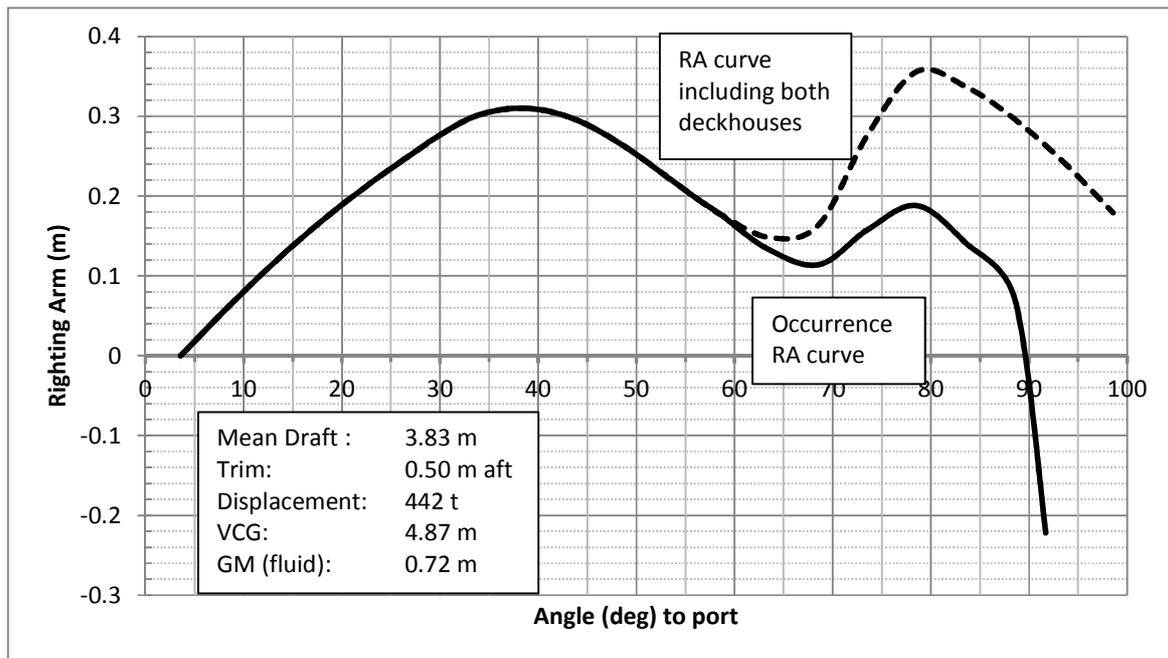
The RA curves presented in *Concordia's* stability booklet are based on the assumption that the weathertight doors in the 2 deckhouses are secured closed, and thus that the deckhouses contribute to the vessel's buoyancy. The resulting effect on the vessel's righting ability can be seen as a second 'bump' in the RA curve beyond angles of around 60° (see Figure 5).

As mentioned previously, the deckhouse doors on the port side were open at the time of the occurrence. The resulting effect on the vessel's righting ability was modelled by eliminating the buoyancy contribution of the relevant deckhouse beyond those angles which would immerse its door(s) as shown in Table 3 – the forward deckhouse was discounted after about 58 degrees and the aft deckhouse after about 88 degrees. The RA curve at the time the occurrence was thereby derived and is shown in Figure 5 below.

Figure 5. Occurrence righting arm (RA) curve⁶³ showing the effect of lost buoyancy from the deckhouses

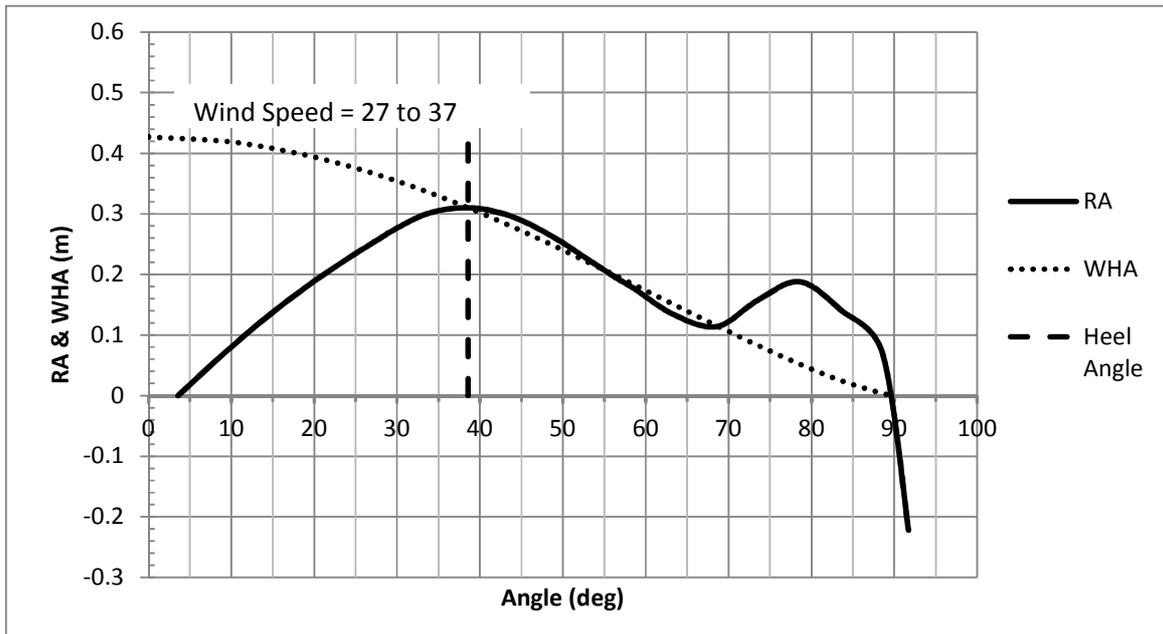
Figure 6. Occurrence righting arm (RA) / wind heeling arm (WHA) curves

It can also be seen in Appendix G that to induce wind heel angles beyond 70° or so, the necessary apparent wind speeds increase significantly to the point where winds in excess of 60 knots would be required to knock the vessel down to an angle in the range of 80° .

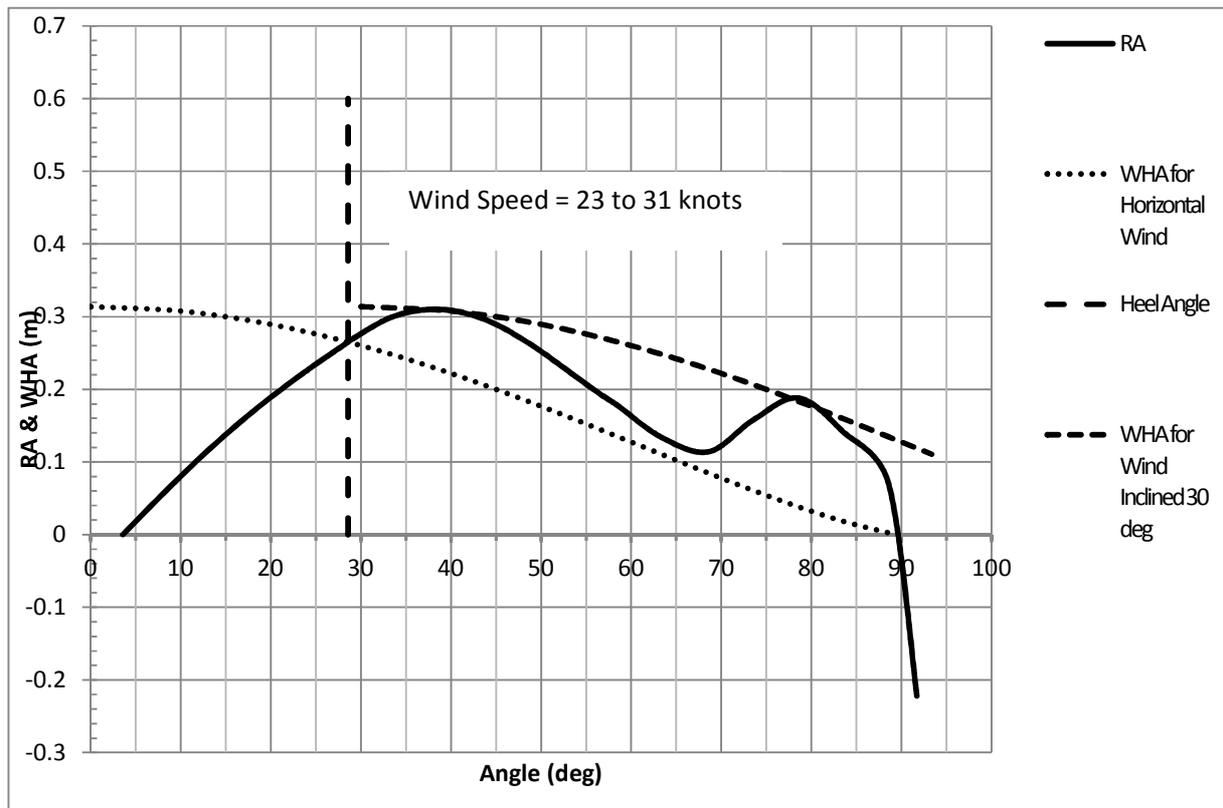
Figure 7 demonstrates this effect on the *Concordia's* righting ability. First, it is assumed that the vessel is heeled to an angle around 28° due to a horizontal wind. According to the relationship between apparent wind speed and heel angle shown in Appendix G, horizontal winds of between 23 and 31 knots would be sufficient to induce this heel angle. Then, the heeling arm curve is shifted 30° to the right, assuming the winds have shifted to 30° from the horizontal. As can be seen in Figure 7, the vessel's righting ability would be completely overcome by this combination of wind speed and inclination.

Figure 7. Wind heeling arm curve for wind inclined 30 ° from the horizontal

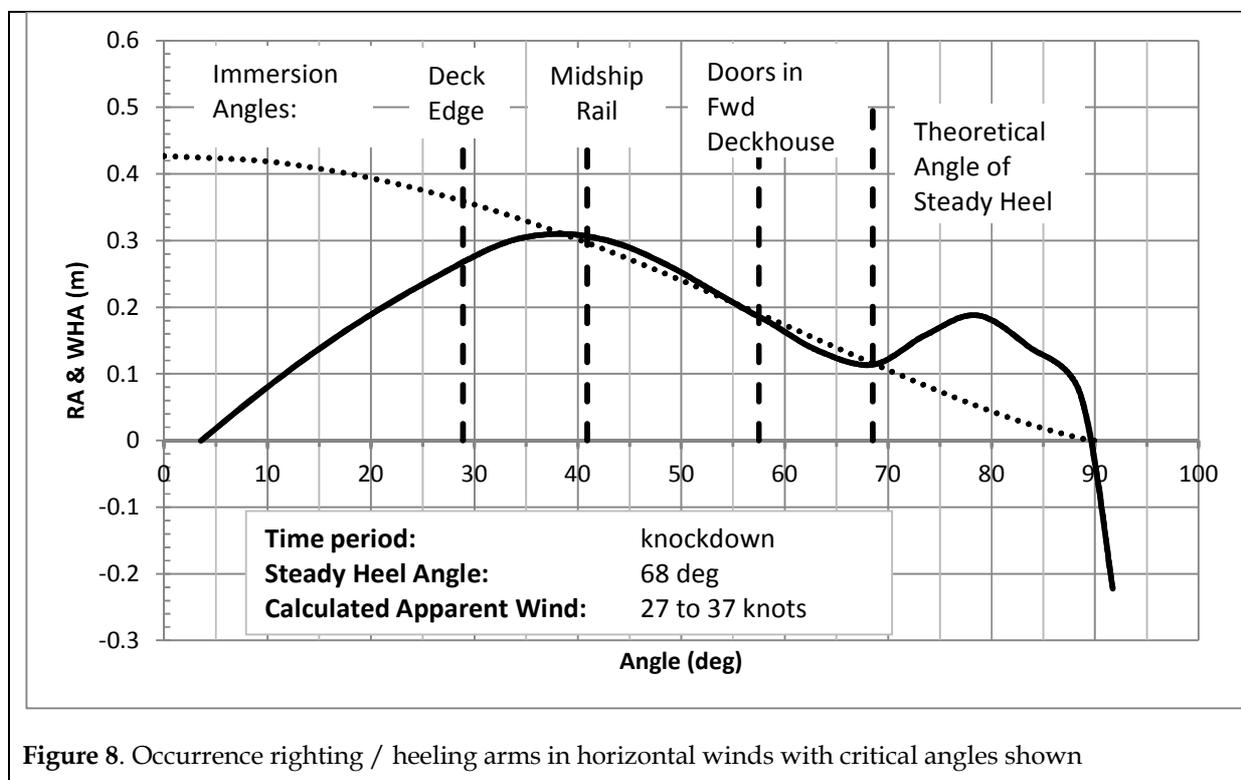
As Figure 8 indicates, although the vessel would theoretically take up a steady heel angle of almost 70° in such winds, water would have begun entering at various critical points before that angle was reached – first, via the open doors in the forward deckhouse (56.5°), then shortly thereafter via the sanitary exhaust vent, which was just aft of that (65°). With all of the doors on the port or lee side, as well as the ventilators and engine room skylight in the open position at the time of the knockdown, there was nothing to prevent or mitigate the downflooding that followed, progressing until the vessel ultimately lost all stability, rolled over, and capsized. The vessel’s ability to recover would have been further hindered by the weight of water entrained in the sails as they submerged, in addition to the possible shifting of weights/equipment.

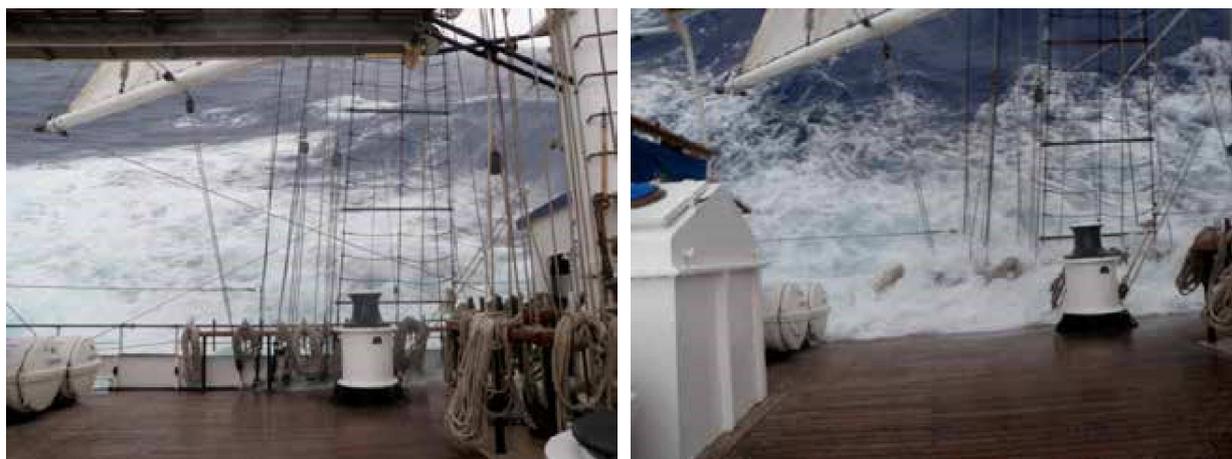
Photo 4. Port deck edge immersed at 29°

Photo 5. Port rail immersed at 41°
