**MARINE INVESTIGATION REPORT
M10F0003**

KNOCKDOWN AND CAPSIZING

**SAIL TRAINING YACHT *CONCORDIA*
300 MILES SSE OFF RIO DE JANEIRO, BRAZIL
17 FEBRUARY 2010**

Report Number M10F0003

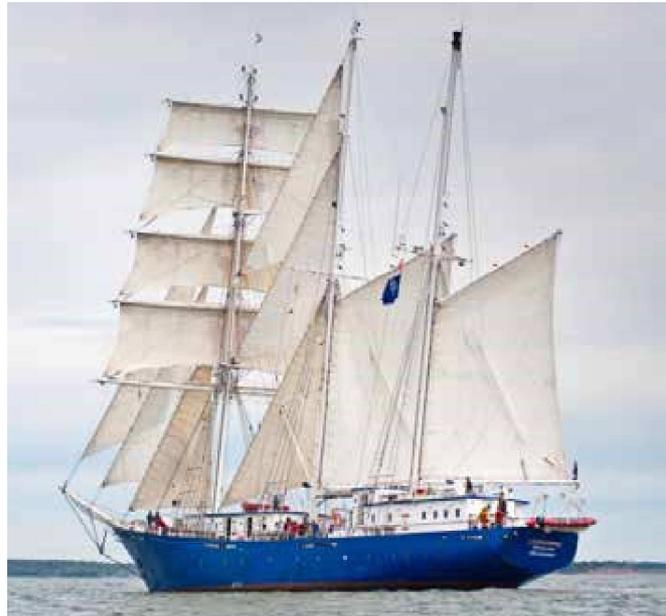
Photo 1. *Concordia*

The sail training vessel *Concordia* was built in Poland as a steel-hulled barquentine (see Photo 1). The vessel was rigged with 3 masts: a square-rigged foremast, as well as fore-and-aft-rigged main and mizzen masts. The vessel could set a fore staysail and 3 jibs forward and 5 square sails on the foremast. Between the main and foremast, the vessel could set 3 staysails; both the main and mizzen masts had gaff topsails and a main and mizzen sail, respectively. (See Appendix A for sail plan.)

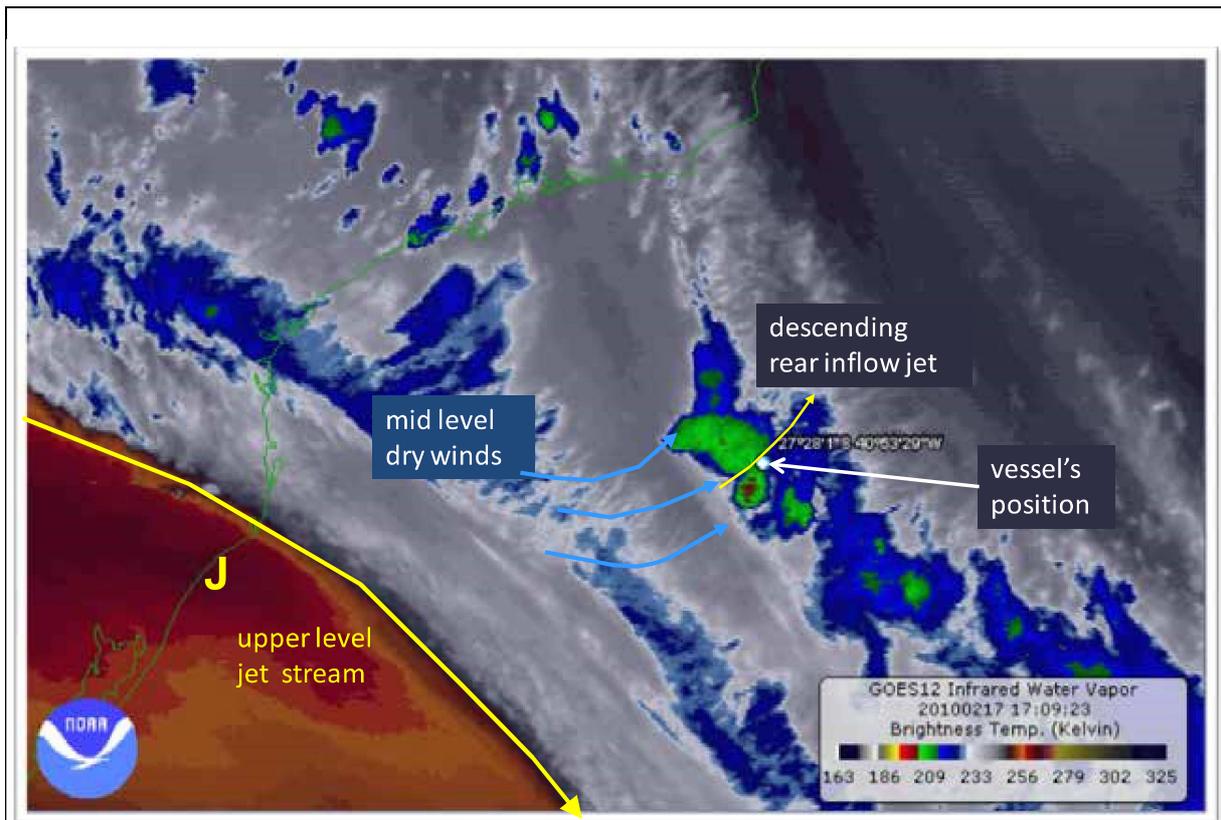
Figure 4. Satellite infrared water vapour imagery taken at 1709 UTC

At 1409, infrared and water vapour satellite imagery indicated a dry rear-inflow notch on the southwest flank of the storm complex (in between the 2 most intense storm cells), pointing directly toward the location of the *Concordia* (see Figure 4). Subsequent satellite imagery also showed a fairly rapid decay of all of the storms over the area in question during the hours following the knockdown.

Approximately 13 minutes before the *Concordia* capsized. The position of the vessel is plotted. (Credit: NOAA)

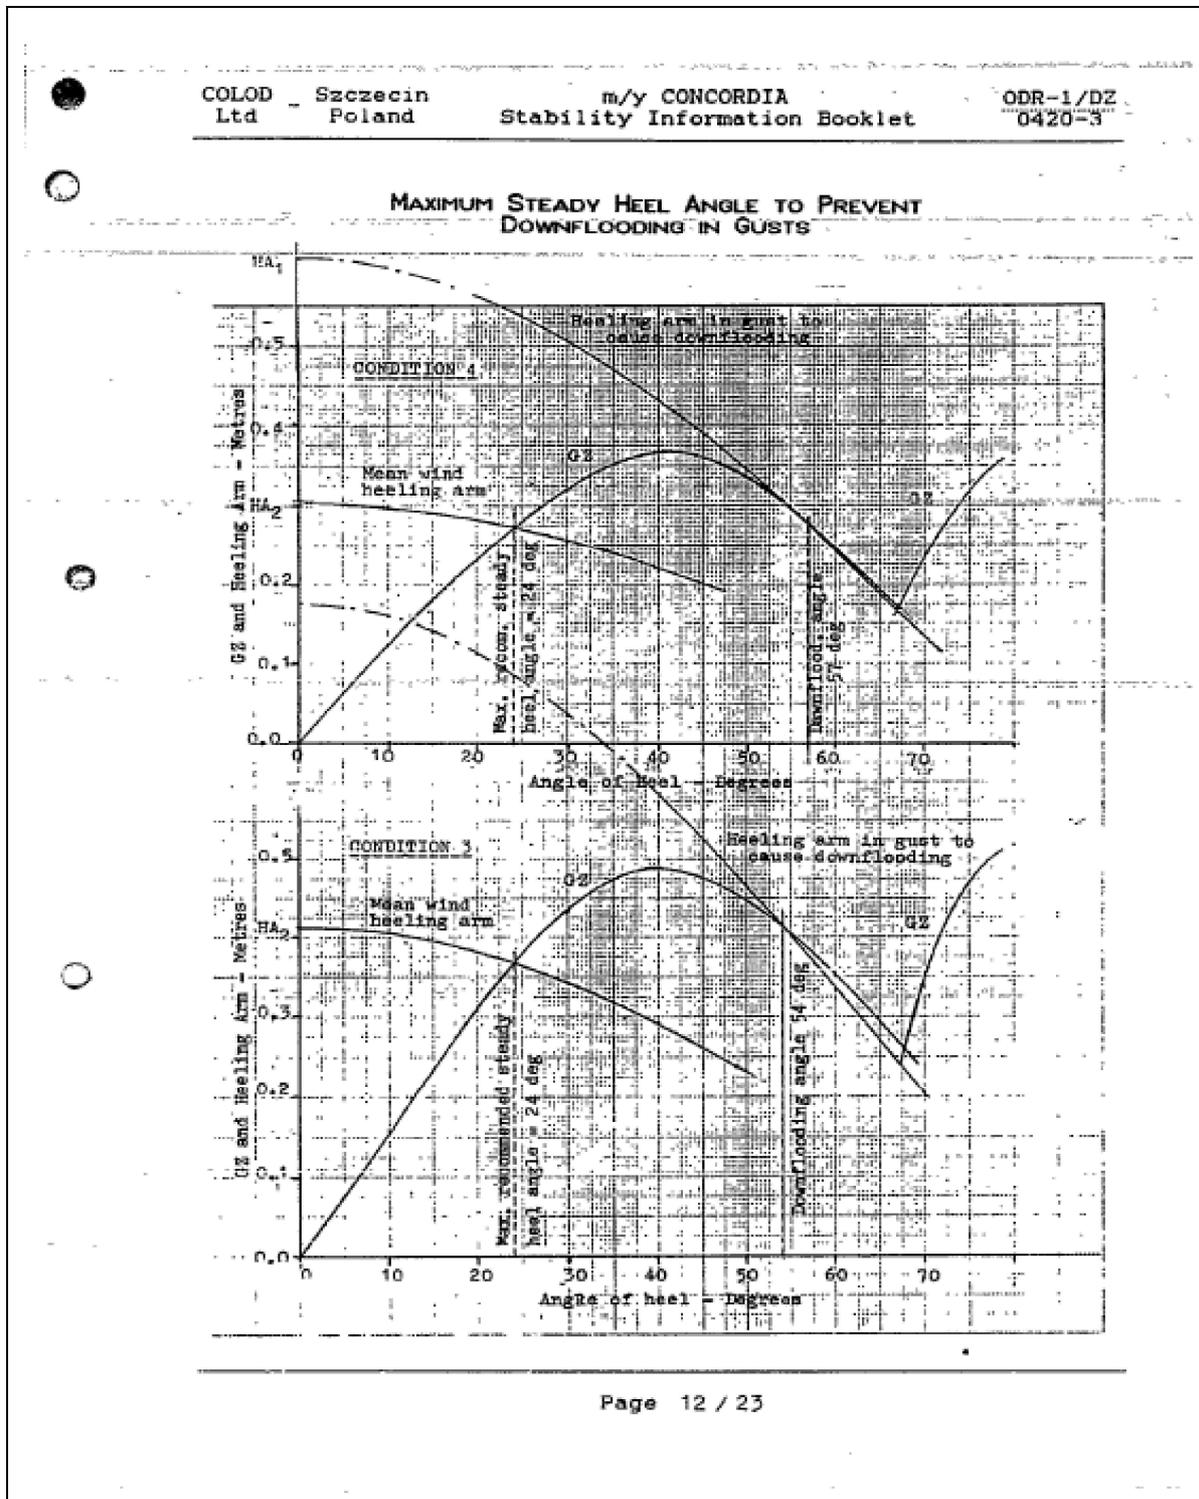
Appendix F – Maximum Steady Heel Angle to Prevent Downflooding in Gusts and Squalls

Curves of maximum steady heel angle indicate the range of mean or steady heel angles beyond which the vessel will suffer downflooding in the event of a squall. Operation of the vessel in cyclonic conditions particularly in the hours of darkness, where severe squalls are imminent requires the recommended maximum steady heel angle to be reduced depending on the mean apparent wind speed in accordance with the curves presented above.

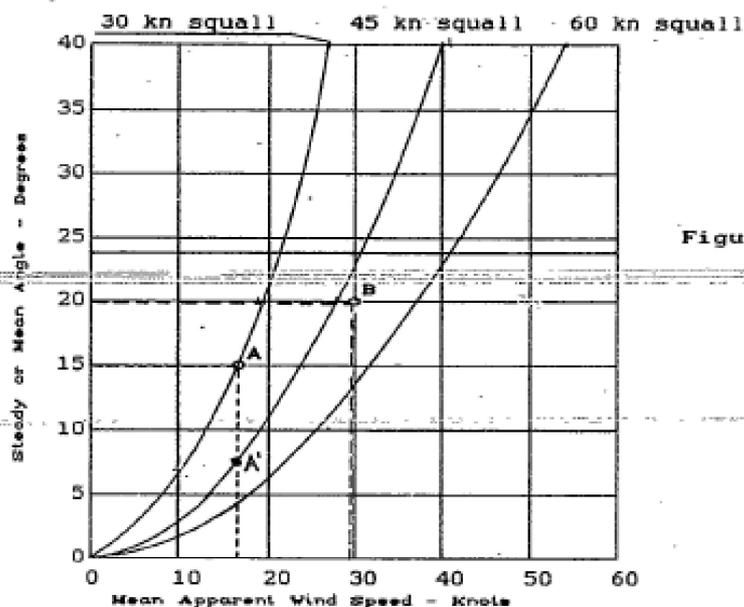
Figure 1

Example A The yacht is reaching, with a steady apparent wind speed of 16 knots. The mean heel angle is 15 degrees. Forecasts and visible cumulo-nimbus clouds suggest squalls may be imminent. By plotting the heel angle and wind speed (point A in Figure 1) the indication is that the vessel will be in danger of heeling to the downflooding angle in squalls of 30 knots. In order to increase safety from downflooding, say, to withstand squalls of up to 45 knots, sails should be handed or reefed to reduce the mean heel angle to 7 degrees (point A' in Figure 1) or less.

Example B The yacht is beating in gusty conditions with a mean apparent wind speed of 30 knots. The mean heel angle is 20 degrees. No squalls are expected. The heel angle is significantly less than 24 degrees, the maximum recommended steady heel angle, and there is therefore a good safety margin against downflooding in a strong gust. Plotting these values of wind speed and heel angle (point B in Figure 1) also indicates that the vessel would not be vulnerable to downflooding in a squall unless it resulted in a wind speed in excess of about 50 knots. There is thus no need to reduce sail area on the grounds of stability.

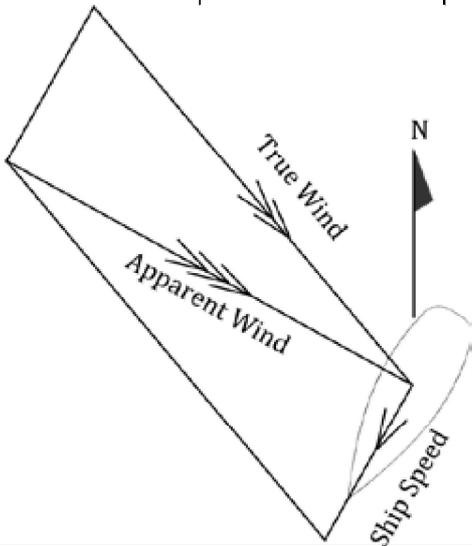
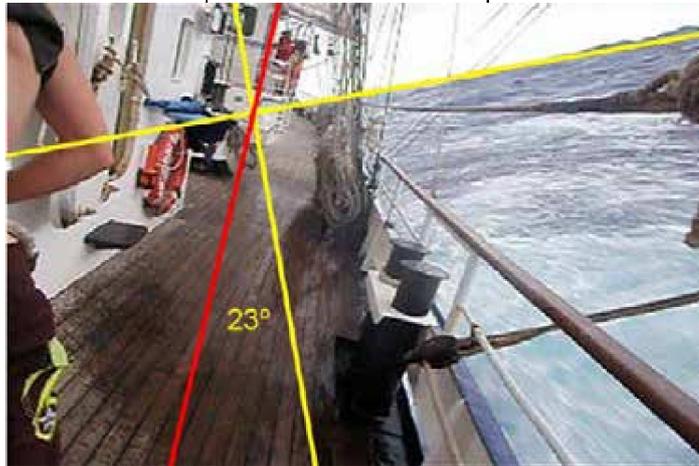
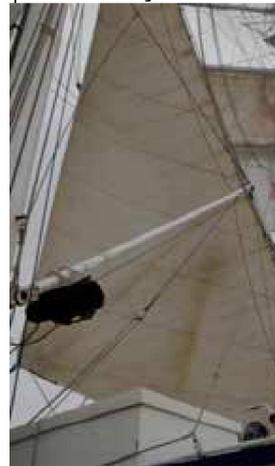
Time Period (Approx)	Ship Speed /Heading	True Wind	Apparent Wind	Heel	Notes
1420 2 to 3 minutes - Student takes video (57 sec) showing conditions on deck and some still photos	Approximation: 9 knots at 210°	Approximation: 25 knots at 320°	Investigation Info: 23 knots Derived Using Approximations for Ship and True Wind Info: 23.5 knots at 88.9° * See notes	Investigation Info: 23° min Calculated range of apparent wind speed for this heel is 20 to 28 knots * See notes	<ul style="list-style-type: none"> Analysis of video minimum angle could be discerned [photo, below] Video shows inner trailing edge flap effect of forestays appear full, indicating angle at least at the Square sails full, indicating angle at least at the
